Recommended Inspection

Failure: On a European certified L-39C were two turbo cooler destroyed by RPM over speed within 4 days.

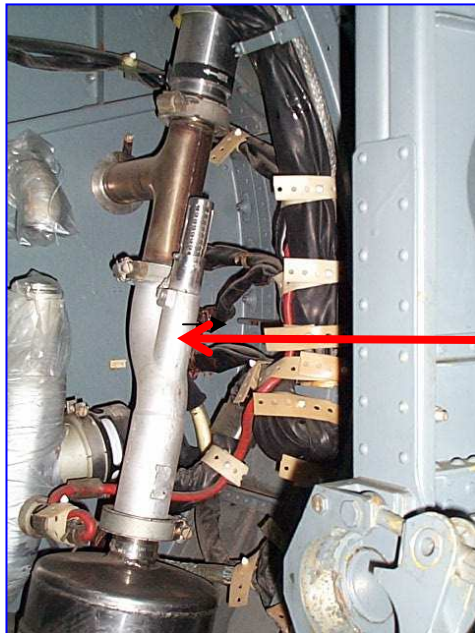
Engine compartment R/H side
of the Fire Wall #32
(Air Conditioning)

Reason: The air flow limiter was seized by corrosion/dirt and blocked in the full opened position. At engine MAX power too much pressure and air volume was delivered to the turbo cooler and exceeded the limits.

Recommendation: Inspect the condition of both limiters during the next maintenance event on your L-39. This inspection is not part of the any scheduled maintenance.

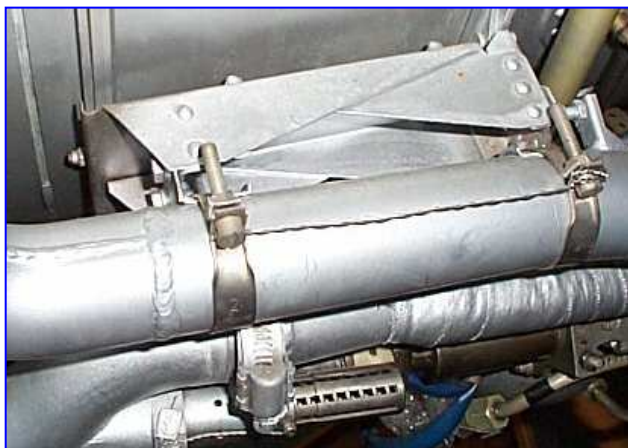
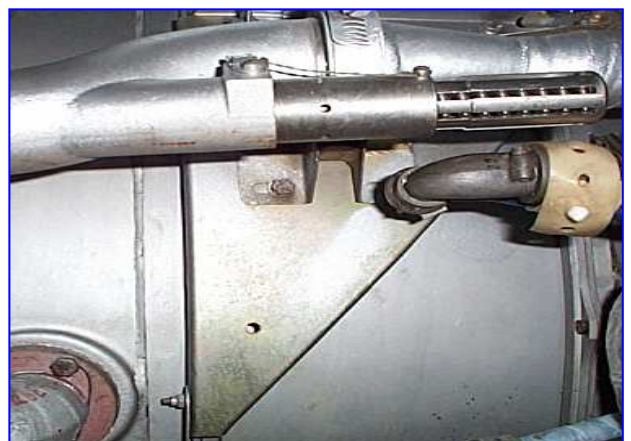
Also check brackets for cracks!

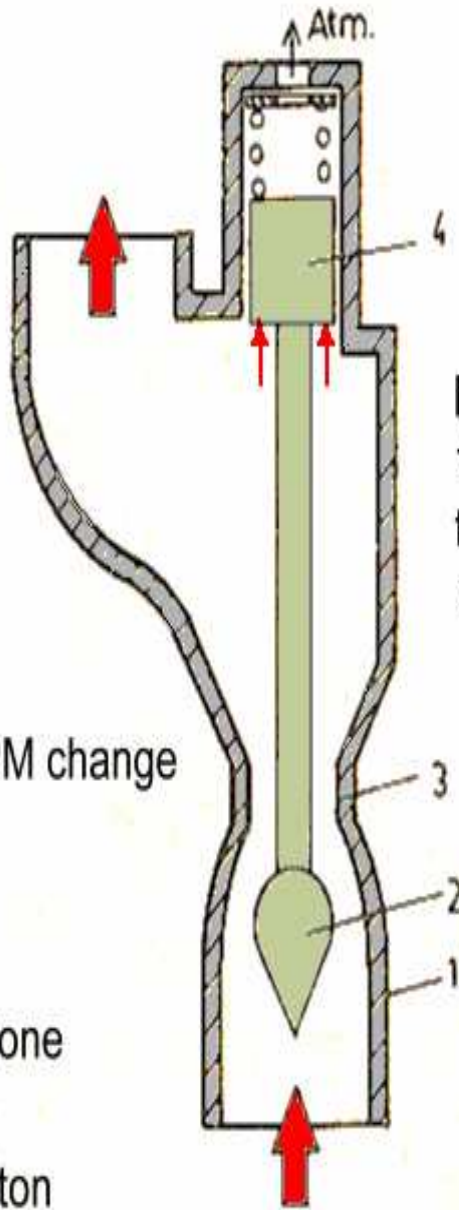
- 1 Casing
- 2 Reducer Cone
- 3 Diffusor
- 4 Control piston

If $p = 5,5 \text{ Kp/cm}^2$
then piston will move
the cone and reduce
air flow to 630 Kg/h
